# RISING FROM THE ASHES

*What is claimed to be the world's largest cement kiln precipitator was rebuilt in record time following extensive damage caused by a fire at the plant*

**H**olnam Cement in Clarksville, Missouri, U.S.A., is thought to be the largest cement kiln in the world. Prior to the fire damage, it took four precipitators working at full capacity to keep the opacity readings within the desired range.

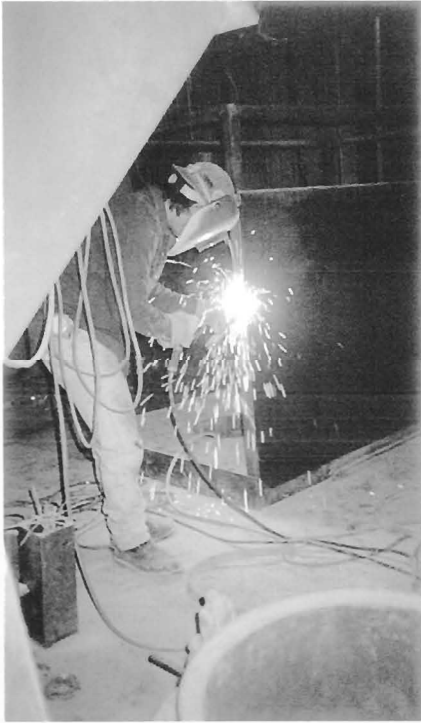
**On-site fabrication assembly was carried out on the precipitator after an 18-week dismantling process revealed extra damage caused by the fire.**

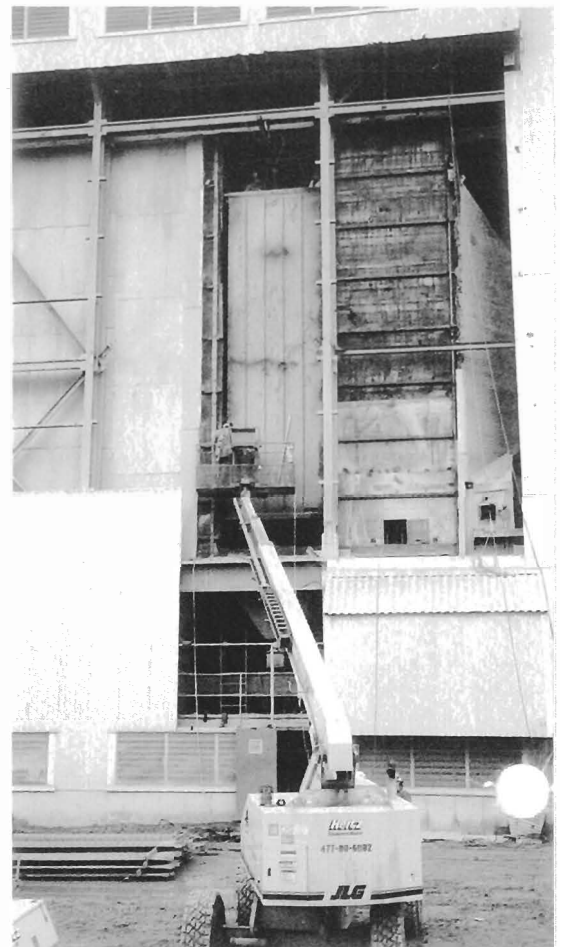
**Workers remove damaged collecting plates in the lower precipitator.**
