# RISING FROM THE ASHES

*What is claimed to be the world's largest cement kiln precipitator was rebuilt in record time following extensive damage caused by a fire at the plant*

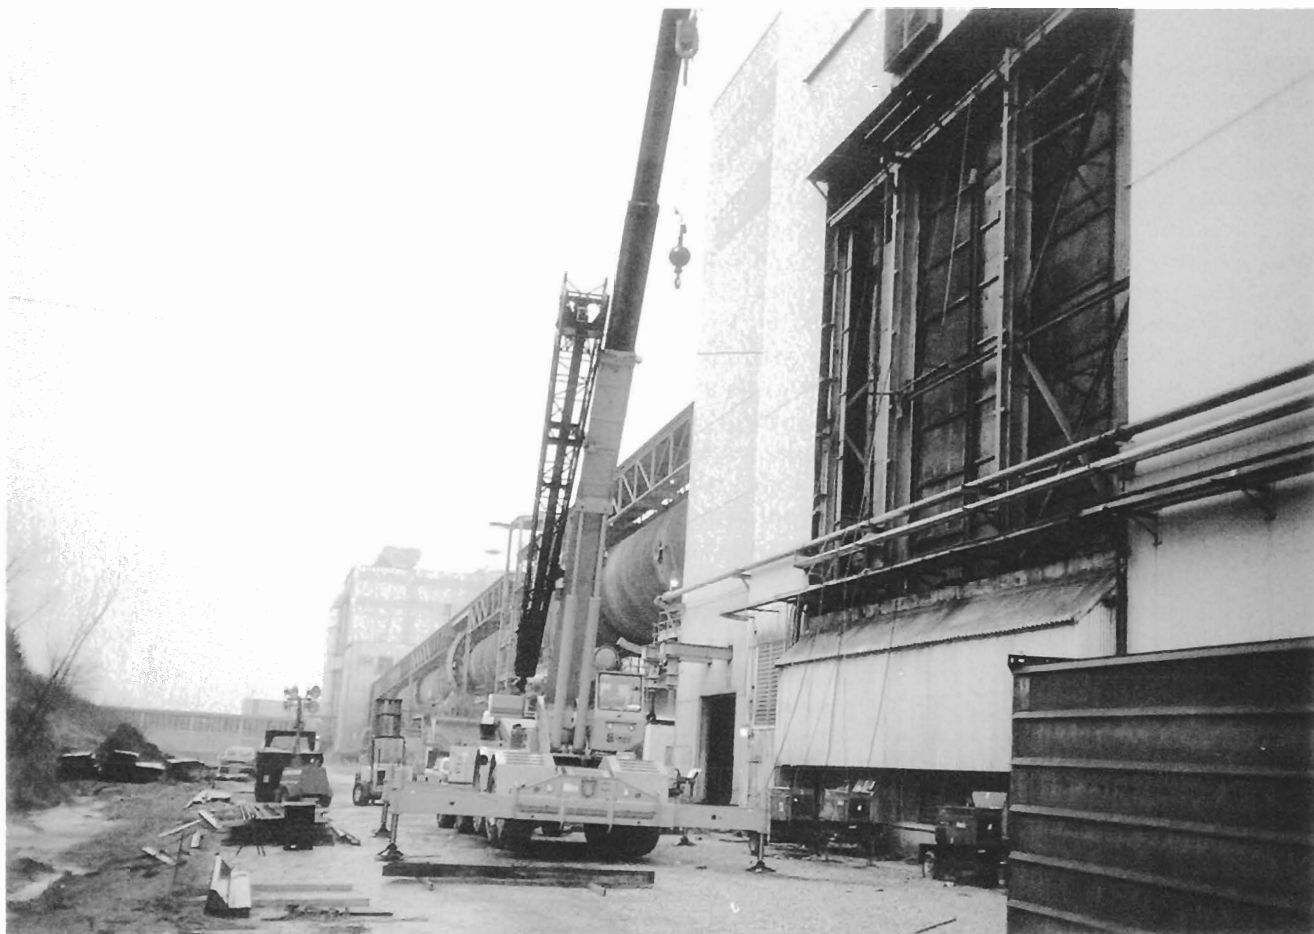
New collecting plates are being installed in the lower precipitator at Holnam Cement's Clarksville, Missouri, U.S.A., plant.

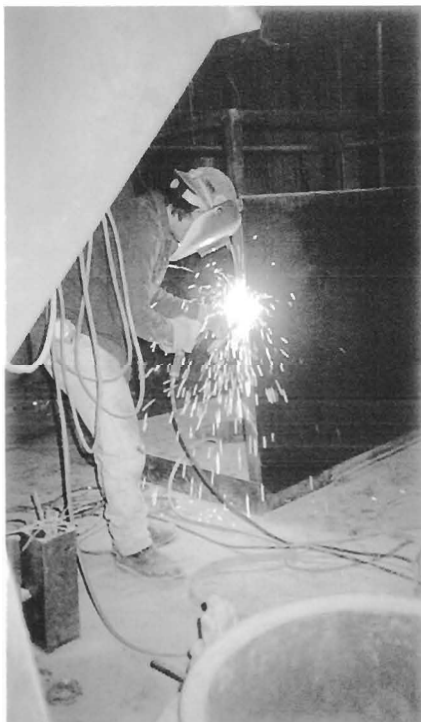
**On-site fabrication assembly was carried out on the precipitator after an 18-week dismantling process revealed extra damage caused by the fire.**

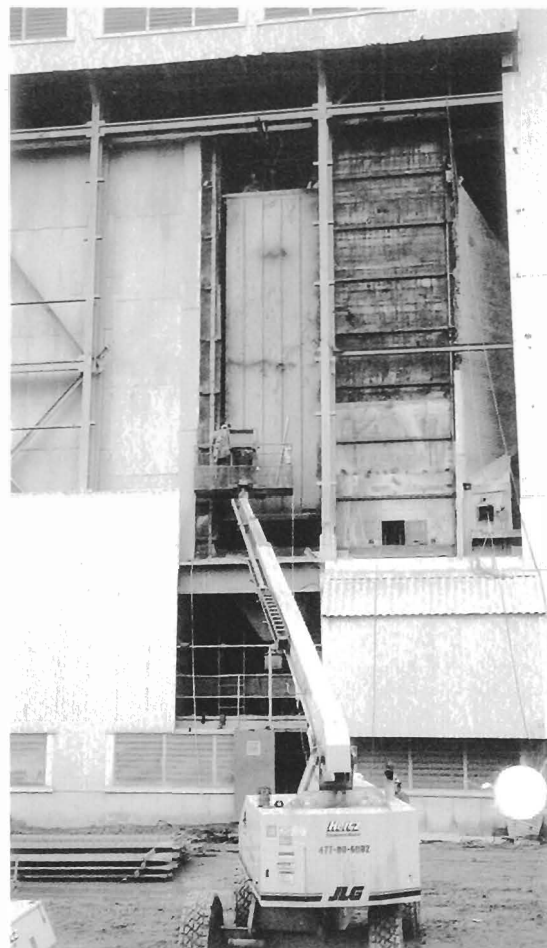
**Workers remove damaged collecting plates in the lower precipitator.**
