Case History Success Story

Holistic Troubleshooting Approach Helps Utility Resolve Baghouse Cleaning Issues, Return to Full Load

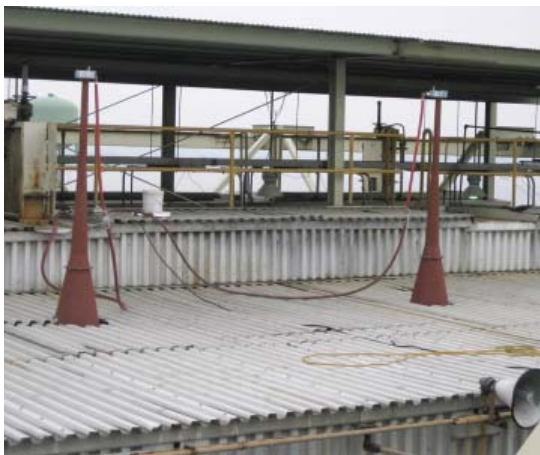
New roof-mounted 60 Hz sonic horns

Based on Phase 1 results, Neundorfer proposed a trial to investigate the impact of improving sonic horn acoustical output. This involved modifying the horn setup in four baghouse compartments to compare results using refurbished existing horns, new 125 Hz horns, new roof-mounted 60 Hz horns and new internally-mounted CD-70 60 Hz horns.

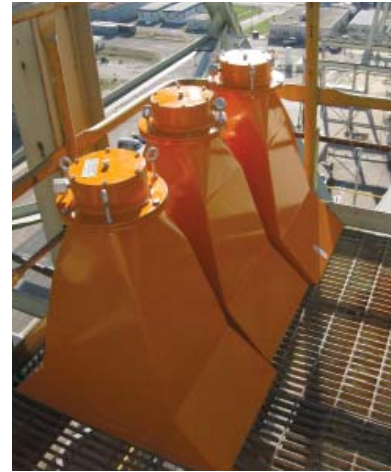
New 125 Hz sonic horns

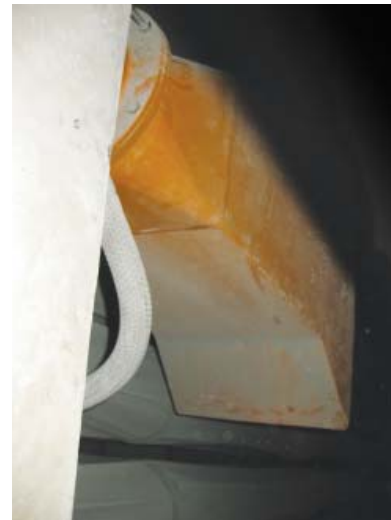
*New 125 Hz sonic horns,
mounted under Reverse Air (R/A)
baghouse walkway*

These positive results were achieved thanks to high energy levels produced by the CD-70 horns (exceeding all others on the market), and a unique under-walkway mounting developed by Neundorfer with the horn supplier. The new mounting scheme positions the bells down between the bags for most effective cleaning power. Also, each horn driver/diaphragm is easily accessible from the walkway, enabling regular maintenance to prevent horn performance from deteriorating over time.

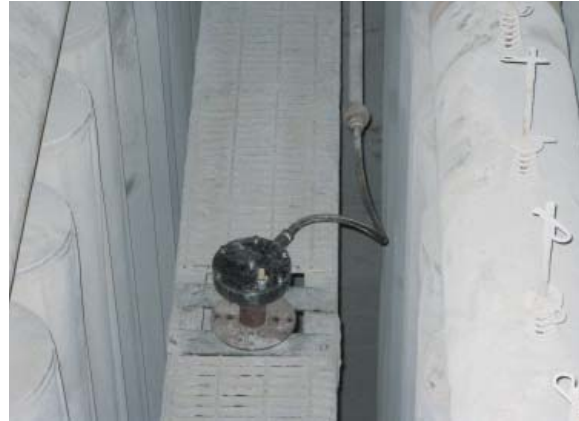
Top view of 60 Hz horns mounted under R/A baghouse walkway

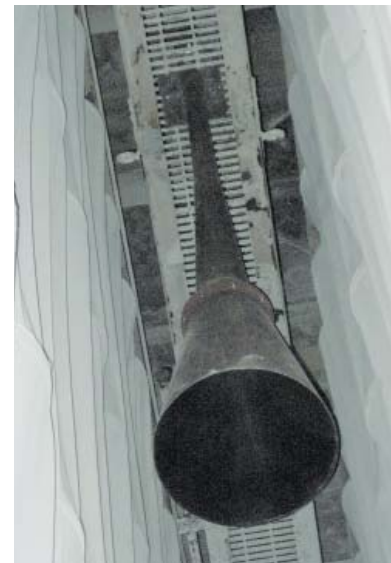
Bottom view of 60 Hz horns mounted under R/A baghouse walkway

When the unit came back online after modifications, the entire baghouse ran at a DP of 6," compared with 10" before retrofit, exceeding Neundorfer's estimate from the trial. That did the trick: the plant was able to ramp back up to full load.
